Mock Inspection Report

2411 NW 88th St, Miami, FL, USA

Jan 23, 2025

This is a mock inspection report to demonstrate that the inspector has performed an inspection according to the InterNACHI® Standards of Practice.

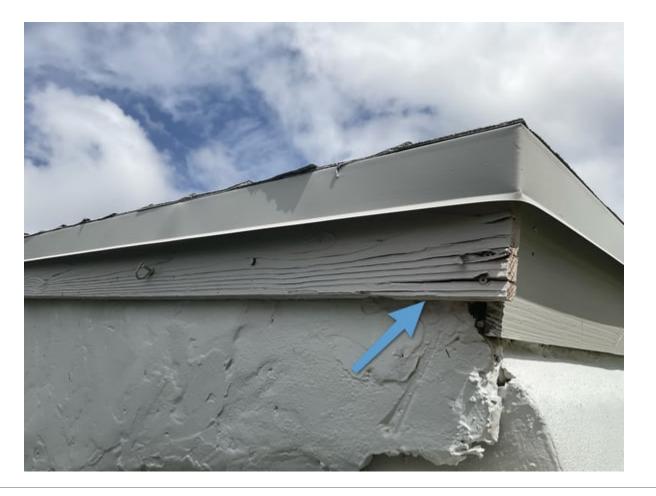
One or more sections of the fascia are damaged. Recommend qualified roofer evaluate & repair.

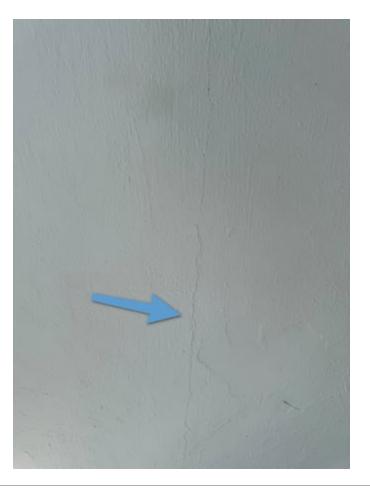
Cracking - Minor Siding showed cracking in one or more places. This is a result of temperature changes, and typical as homes with stucco age. Recommend monitoring.

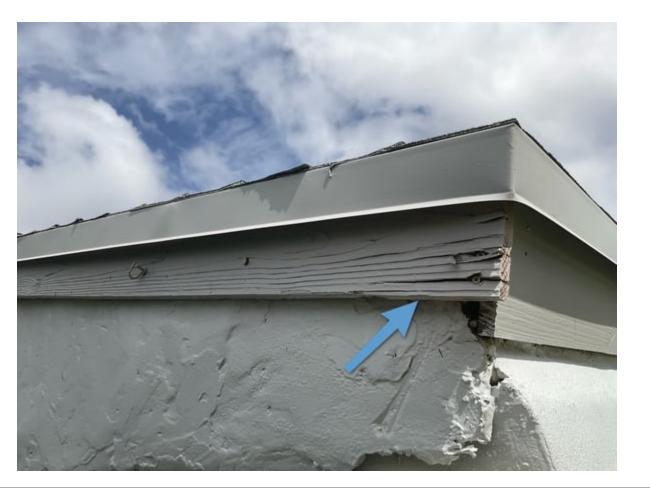
Fascia - Damaged One or more sections of the fascia are damaged. Recommend qualified roofer evaluate & repair.

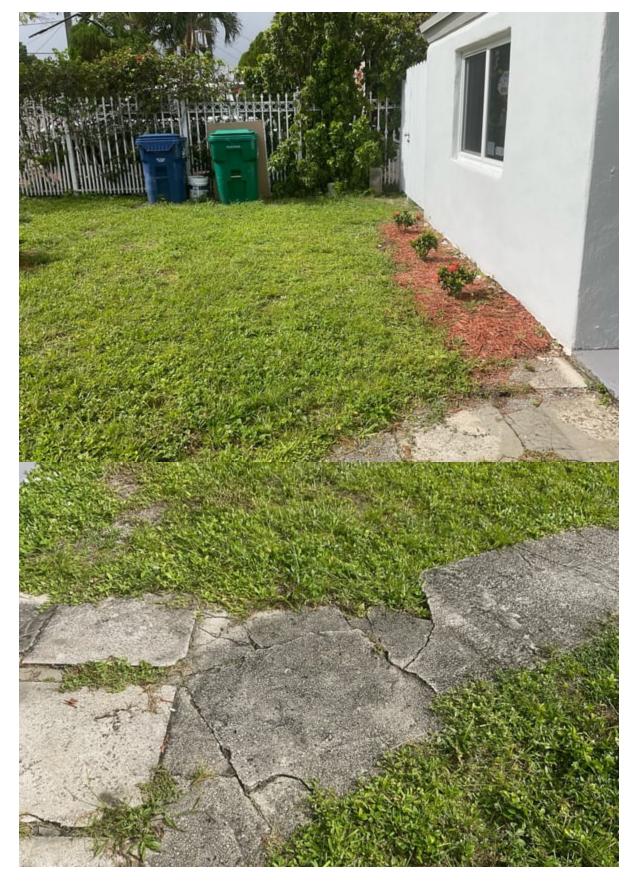
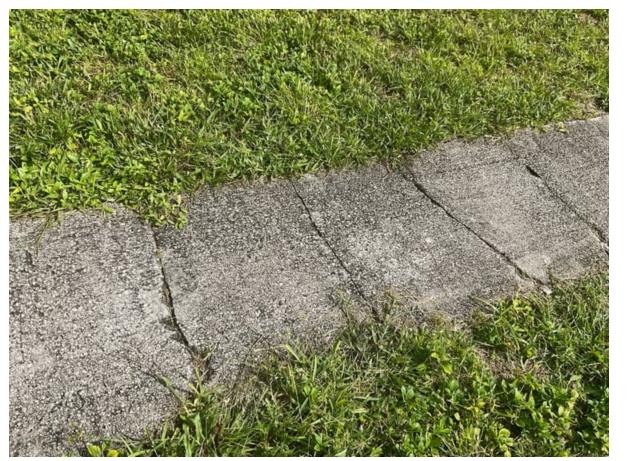
Cracking - Minor Siding showed cracking in one or more places. This is a result of temperature changes, and typical as homes with stucco age. Recommend monitoring. Driveway Cracking - Minor Minor cosmetic cracks observed, which may indicate movement in the soil. Recommend monitor and/or have concrete contractor patch/seal.

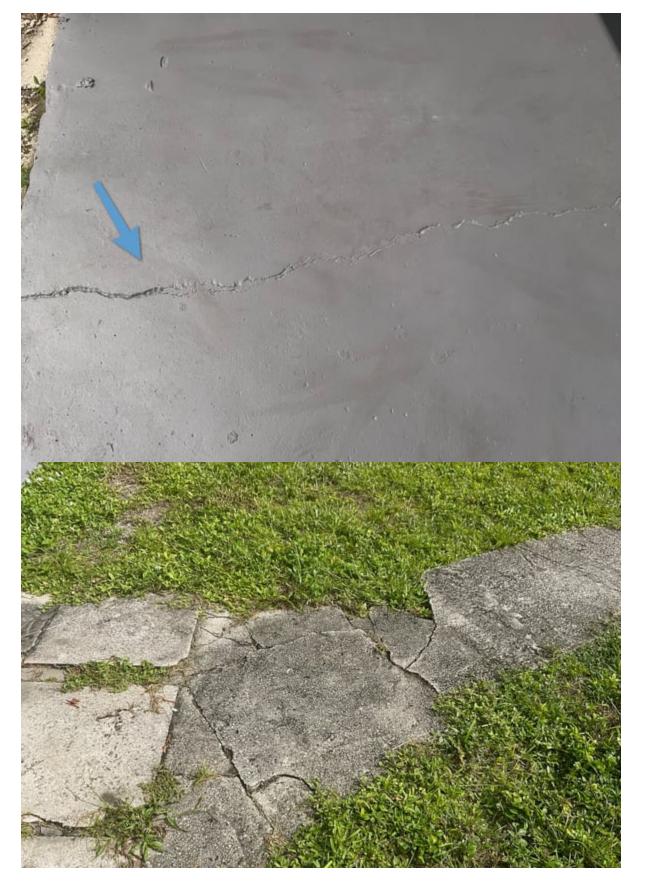
Driveway Cracking - Minor Minor cosmetic cracks were observed, which may indicate movement in the soil. Recommend monitor and/or have concrete contractor patch/seal.

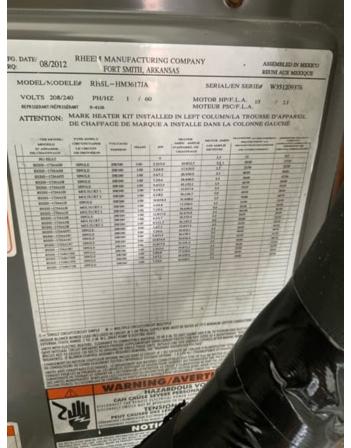
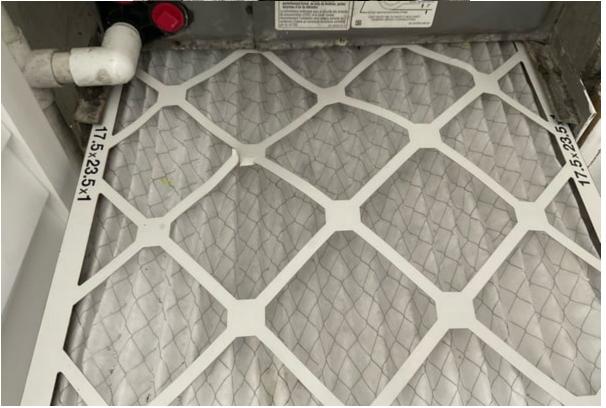
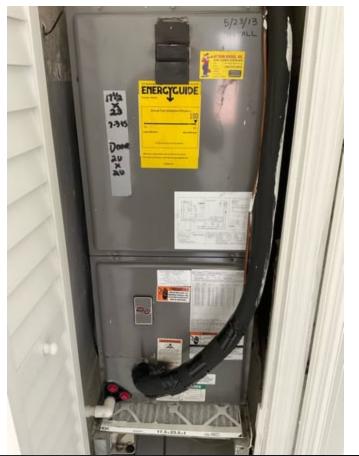
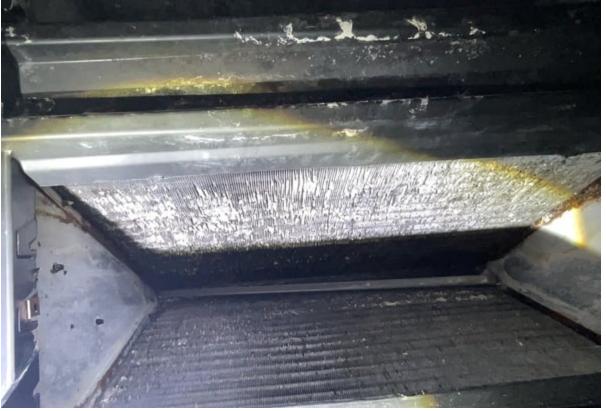
• Central air conditioning system: HVAC is more than 10 years old/preventive replacement is recommended The average lifespan of an air conditioning unit is around 10 to 15 years. Regular maintenance and proper care can help extend its life. Older HVAC systems are generally less energy-efficient than newer models. If you notice a significant increase in energy bills or you want to reduce your energy consumption, upgrading to a more energy-efficient system could be beneficial. HVAC is more than 10 years old / preventive replacement recommended The average lifespan of an air conditioning unit is around 10 to 15 years. Regular maintenance and proper care can help extend its life. Older HVAC systems are generally less energy-efficient than newer models. If you notice a significant increase in energy bills or you want to reduce your energy consumption, upgrading to a more energy-efficient system could be beneficial.

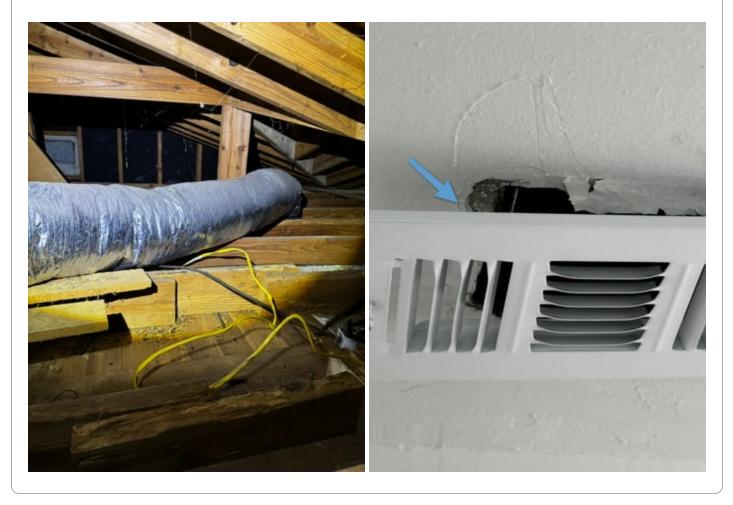
Loose AC ducts in attic areas Missing security straps Loose AC register/s

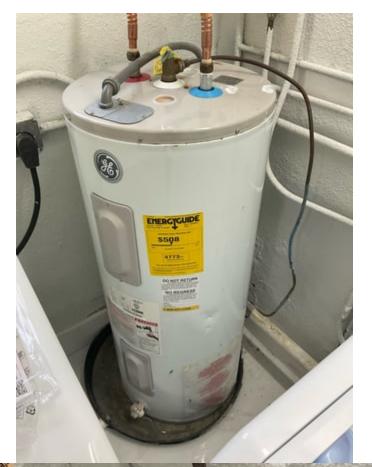
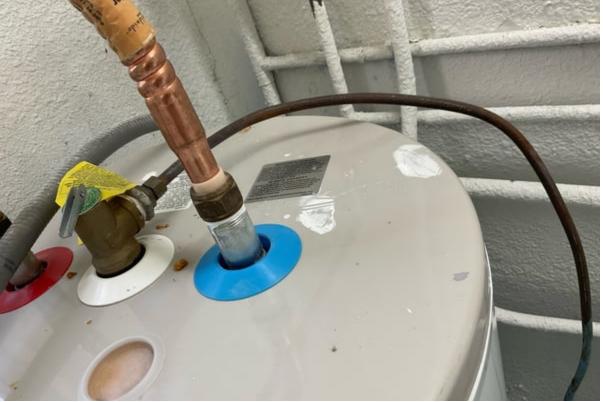
Manufacturer GE I recommend flushing & servicing your water heater tank annually for optimal performance. Water temperature should be set to at least 120 degrees F to kill microbes and no higher than 130 degrees F to prevent scalding. Water heater is more than 10 years old / preventive replacement recommended.

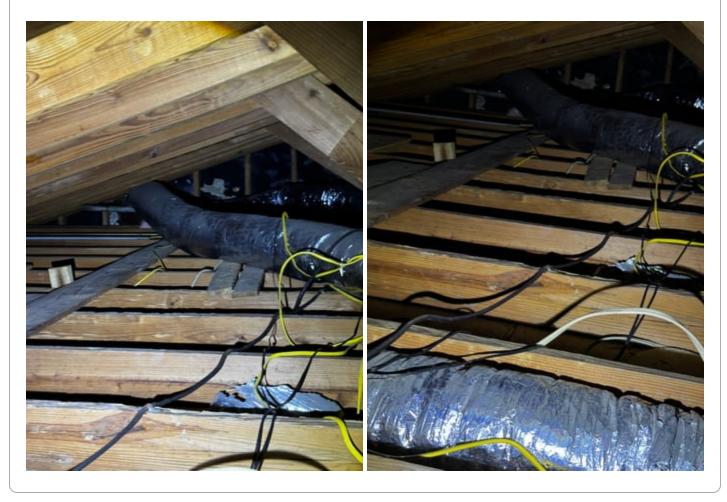
Missing insulation in attic area Not having attic insulation can lead to several disadvantages and negative consequences. The lack of insulation forces your HVAC system to work harder to compensate for the heat loss or gain. This increased workload can lead to more frequent breakdowns, higher repair costs, and a shorter overall lifespan for your heating and cooling equipment. Proper attic insulation can lead to significant energy savings over time. Without it, you miss out on the opportunity to reduce your energy bills and potentially recoup the insulation cost through energy savings.

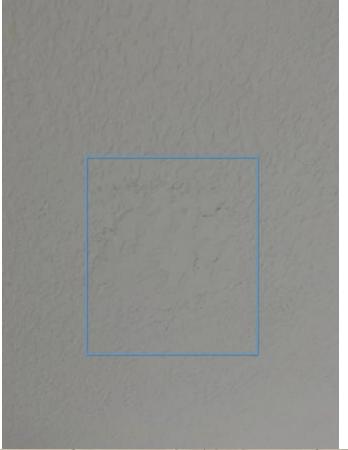
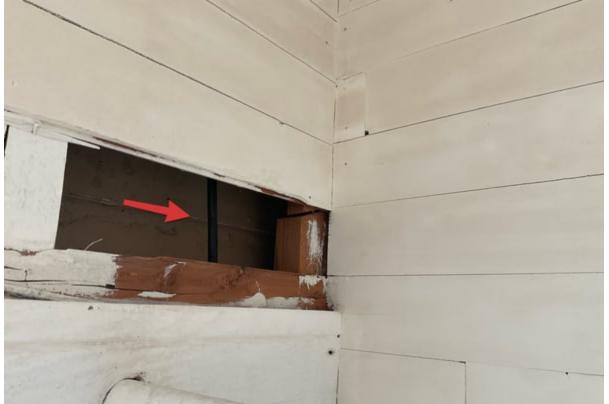
Incomplete repairs on closet walls. Signs of repairs in interior ceilings The inspector recommend a further evaluation.
