Mock Inspection Report

2411 NW 88th St, Miami, FL, USA

Jan 23, 2025

This is a mock inspection report to demonstrate that the inspector has performed an inspection according to the InterNACHI® Standards of Practice.

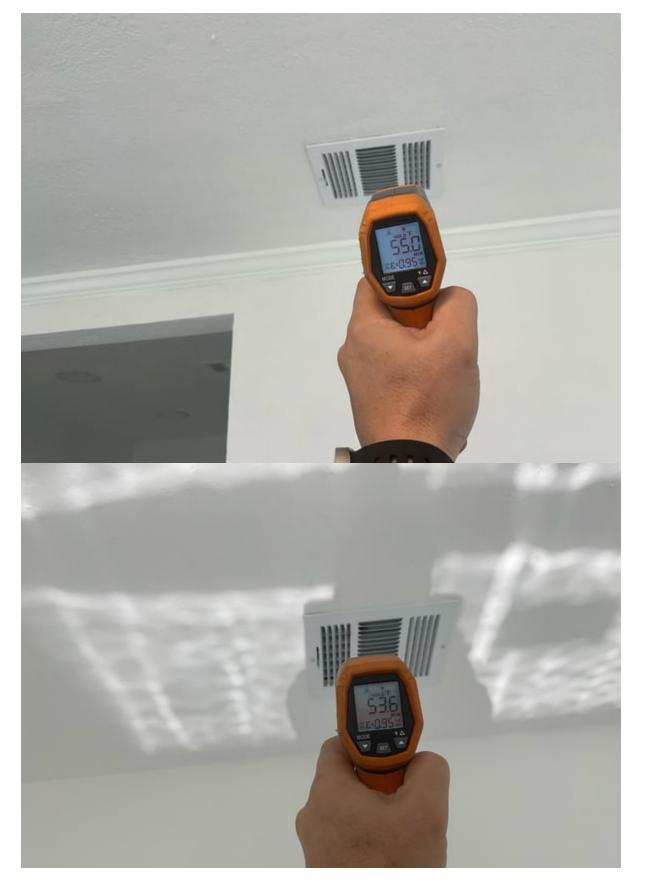
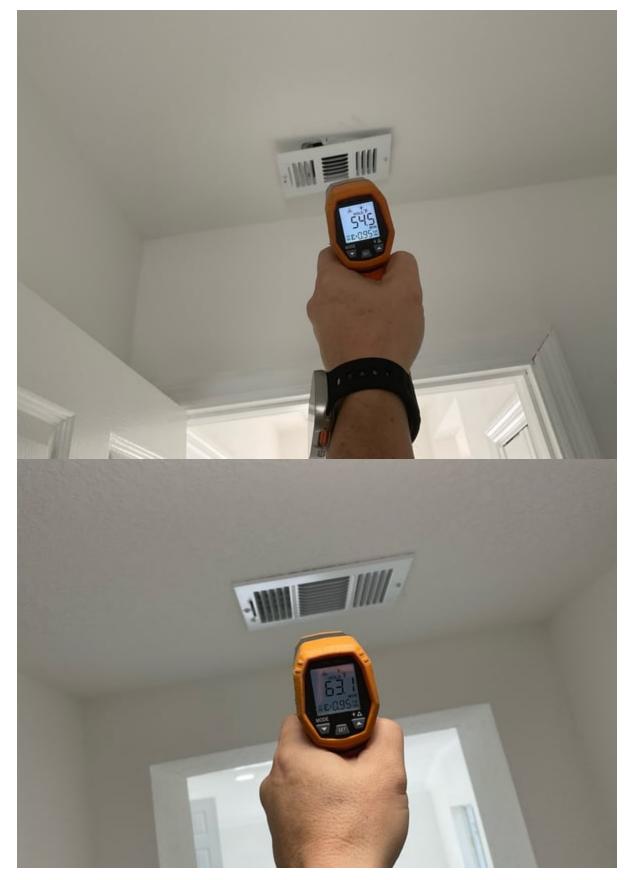
Cooling System (using normal operating controls)	Minor Defect
A/C Temperature at the time of the inspection.

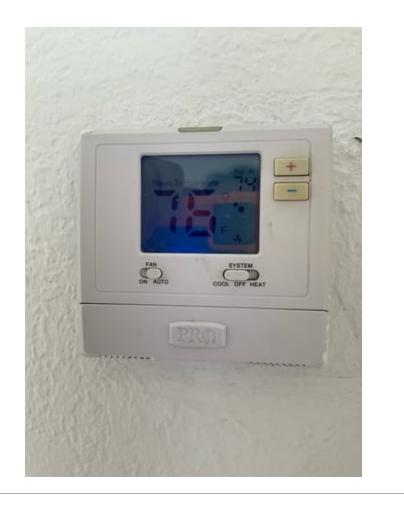
• Central air conditioning system: HVAC is more than 10 years old/preventive replacement is recommended The average lifespan of an air conditioning unit is around 10 to 15 years. Regular maintenance and proper care can help extend its life. Older HVAC systems are generally less energy-efficient than newer models. If you notice a significant increase in energy bills or you want to reduce your energy consumption, upgrading to a more energy-efficient system could be beneficial. HVAC is more than 10 years old / preventive replacement recommended The average lifespan of an air conditioning unit is around 10 to 15 years. Regular maintenance and proper care can help extend its life. Older HVAC systems are generally less energy-efficient than newer models. If you notice a significant increase in energy bills or you want to reduce your energy consumption, upgrading to a more energy-efficient system could be beneficial.

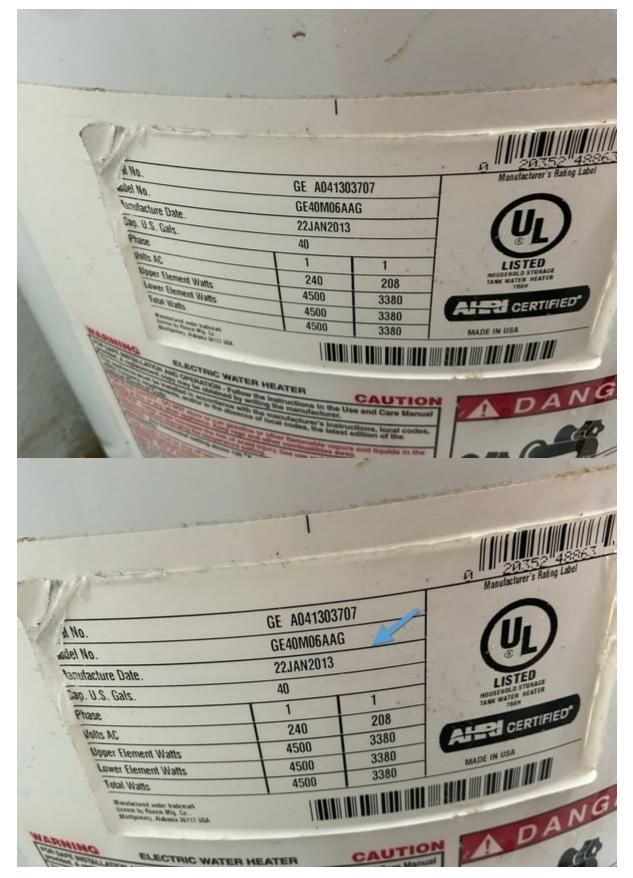
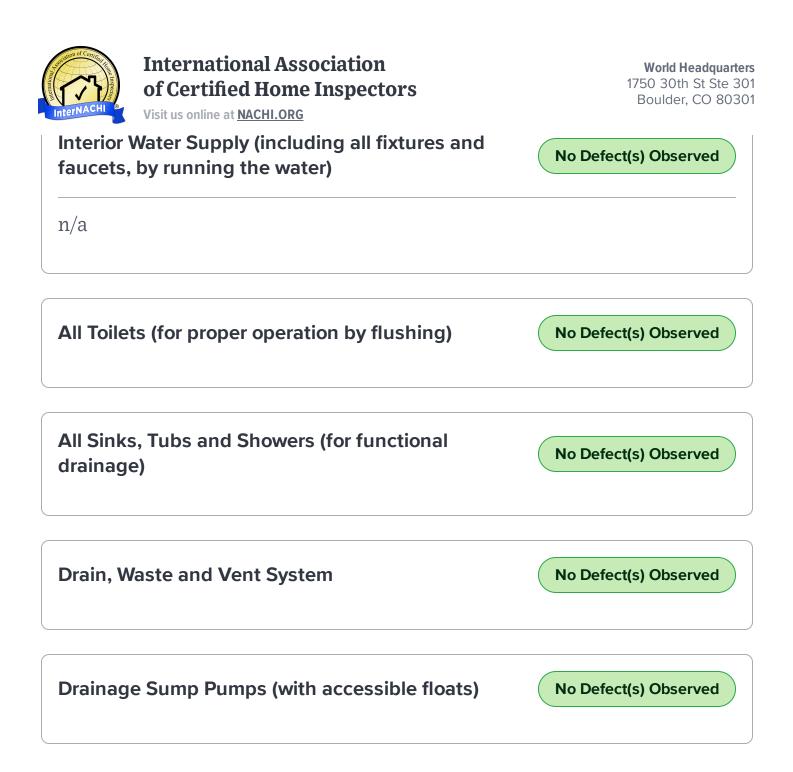
Manufacturer GE I recommend flushing & servicing your water heater tank annually for optimal performance. Water temperature should be set to at least 120 degrees F to kill microbes and no higher than 130 degrees F to prevent scalding. Water heater is more than 10 years old / preventive replacement recommended.

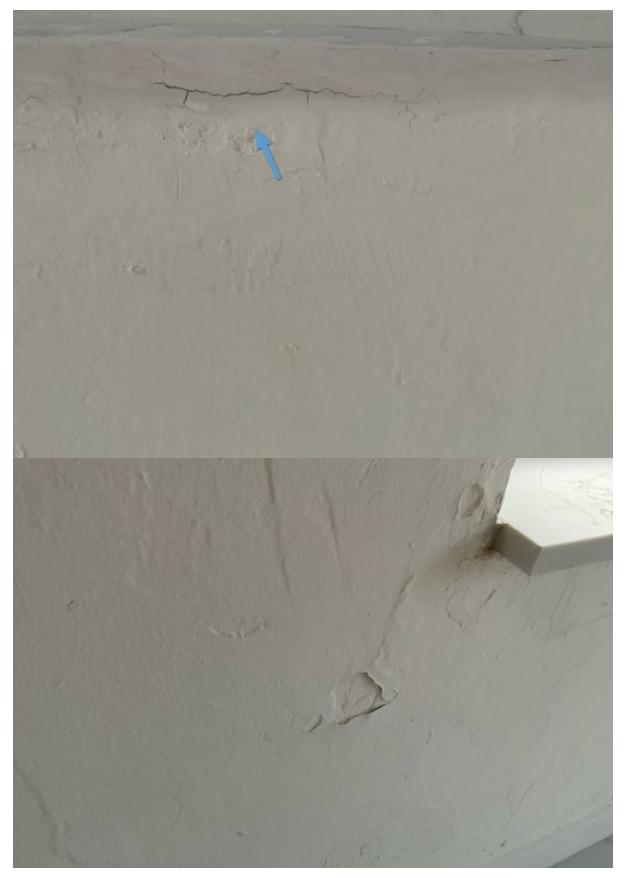
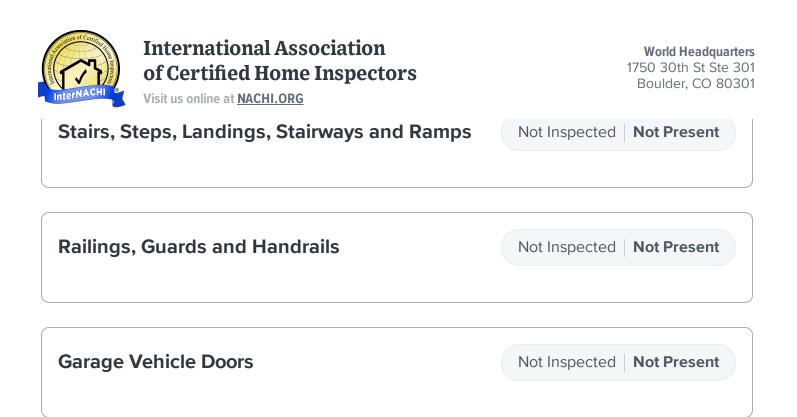
Incomplete repairs on closet walls. Signs of repairs in interior ceilings The inspector recommend a further evaluation.
